# Challenges of Cold Conditioning and Static Testing the Ares Demonstration Motor (DM-2)

Mechanical Test Engineer

ATK Aerospace Systems

**April 2011**

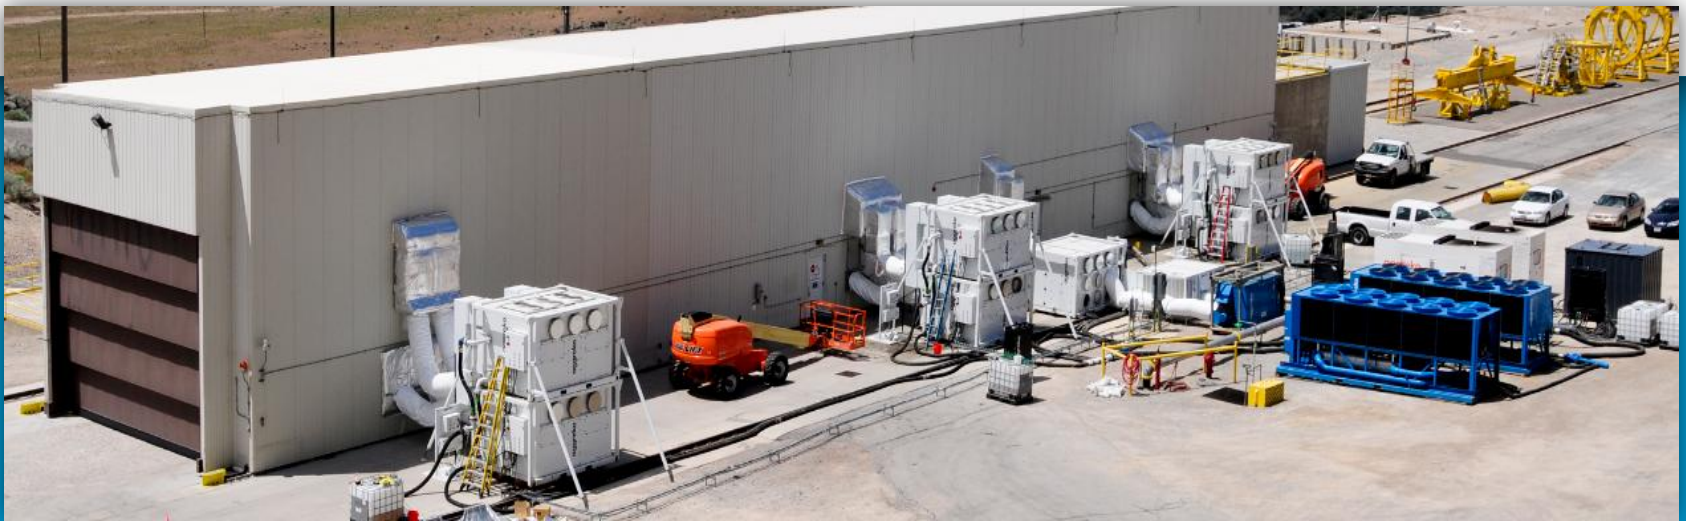
**Aggreko was contracted to provide heavy-duty conditioning equipment for this test**

- The equipment needed to provide continuous subfreezing temperatures to the building for a minimum of two months
- The equipment needed to provide at least 20 °F inlet air to the building
- The equipment needed to modulate temperatures and air flow speeds to the building
- Air must be filtered to prevent contamination of the motor and the conditioning fluid used should be environmentally friendly

## Equipment set-up consisted of:

- Two 200-ton chillers filled with a 50% propylene glycol solution called “brine”
  - Capable of cooling the brine solution to -10 °F; however, the colder the temperature the less capacity. For this conditioning effort, the capacity of an individual chiller was approximately 85 tons
- Two 1,000-gpm pumps
- Two 500-kW diesel generators
  - Primary purpose was to provide power for the chillers; however, cabling was pre-routed to allow all the equipment to run off the generators
- 2,300-gal double-walled fuel tank

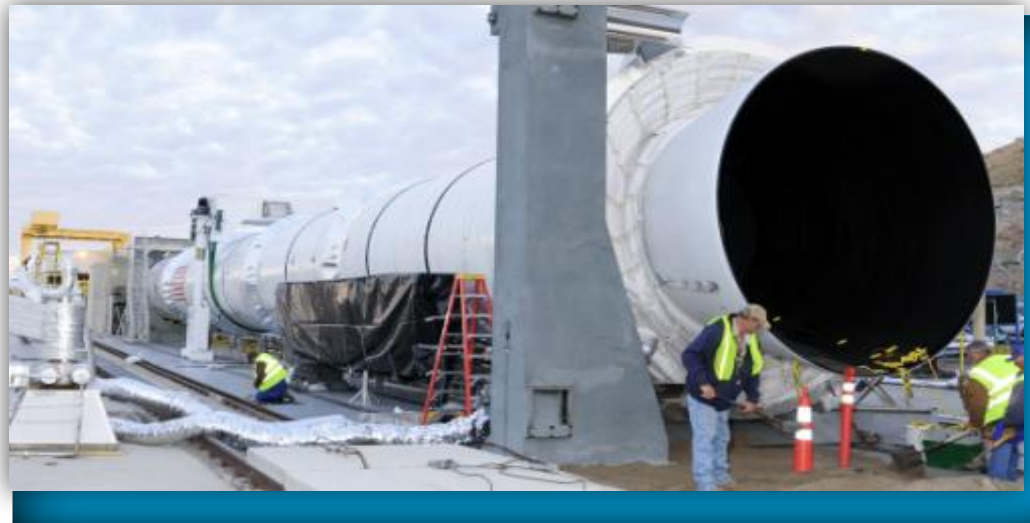
- Internal components within the nozzle that are responsible for vectoring needed to be kept at 64 to 94 °F during conditioning
- A nozzle skirt was installed to close off and insulate the nozzle cavity. A separate conditioning cart was used to blow in heated air
  - The conditioning cart had to run at full capacity at approximately 170 °F at its source, but was barely maintaining the minimum acceptance range. This was mainly due to leakage through the skirt
  - Aluminum foil bubble wrap was added to the skirt to act as an air block and provide additional insulation. This allowed main conditioning to achieve lower temperatures

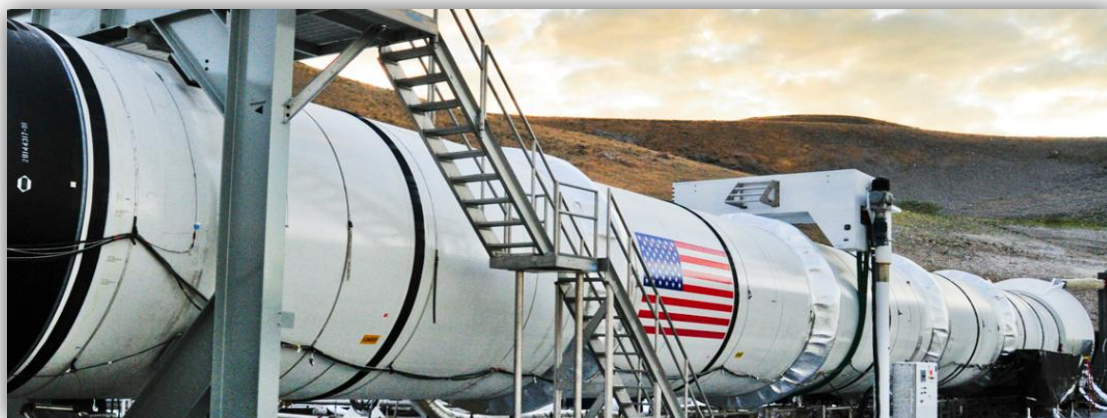
**Field Joint**

## Shroud design consisted of six elements:

- Aluminum braces acted as ribs for the shrouds to provide structure
  - Secured to the case by two 139-lb magnets
  - Twelve braces were installed on each field joint
- Aluminum air inlets were designed with a 12-in. diameter to accommodate needed air flow rate per the thermal analysis
  - Secured to the case by eight 139-lb magnets and shroud material
- Electrostatic dissipative ducting
- Aluminum air flow manifold was designed to connect to the Aggreko equipment and flow air to each joint. The manifold had regulators to restrict air flow to individual joints

- To verify sealing surface capabilities at extreme low temperatures and eliminate the need for joint heaters, the O-rings needed to be between 32 and 38 °F at the time of static test
  - Newly designed conditioning shrouds were used to externally cool each of the four field joints after the test bay building was rolled back. Shrouds were designed to be easily installed and not damage the motor during test. The temperature and air speed could also be controlled for each joint
  - Even though the O-rings needed to be freezing, the J-leg feature and insulation inboard were not supposed to get below 35 °F
  - Conditioning had to be turned off one hour prior to static test to prevent any negative influence of the measurement data
  - It was determined by thermal analysis that even with active conditioning, the heat from the sun would warm the joints beyond an acceptable range after 10 a.m.

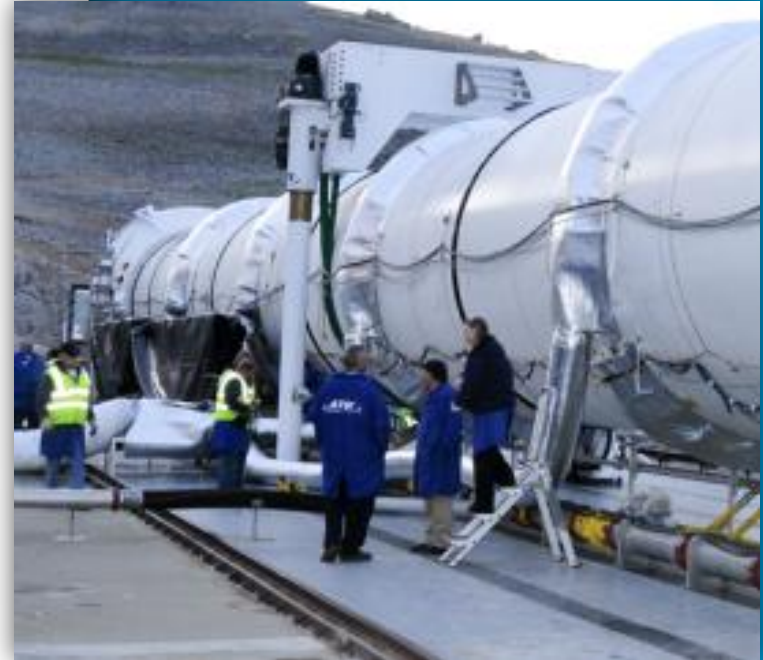
- Aluminum foil bubble wrap was used as the shrouding material. It was chosen because it is an excellent air block; it reflects approximately 97% of the radiant energy; it has an adequate insulation factor up to  $-4^{\circ}\text{F}$ ; and it is thin, light-weight, and flexible
  - Each roll was 4 ft by 75 ft, which would adequately cover the joints
- High-strength aluminum foil tape was used to secure the shroud material to the case. The tape had a high adhesion-to-steel ratio and was acceptable to  $-65^{\circ}\text{F}$
- Temperature and air speed were monitored with a hand-held manometer. The temperature could be regulated by adjusting the manifold, AHU, and chiller

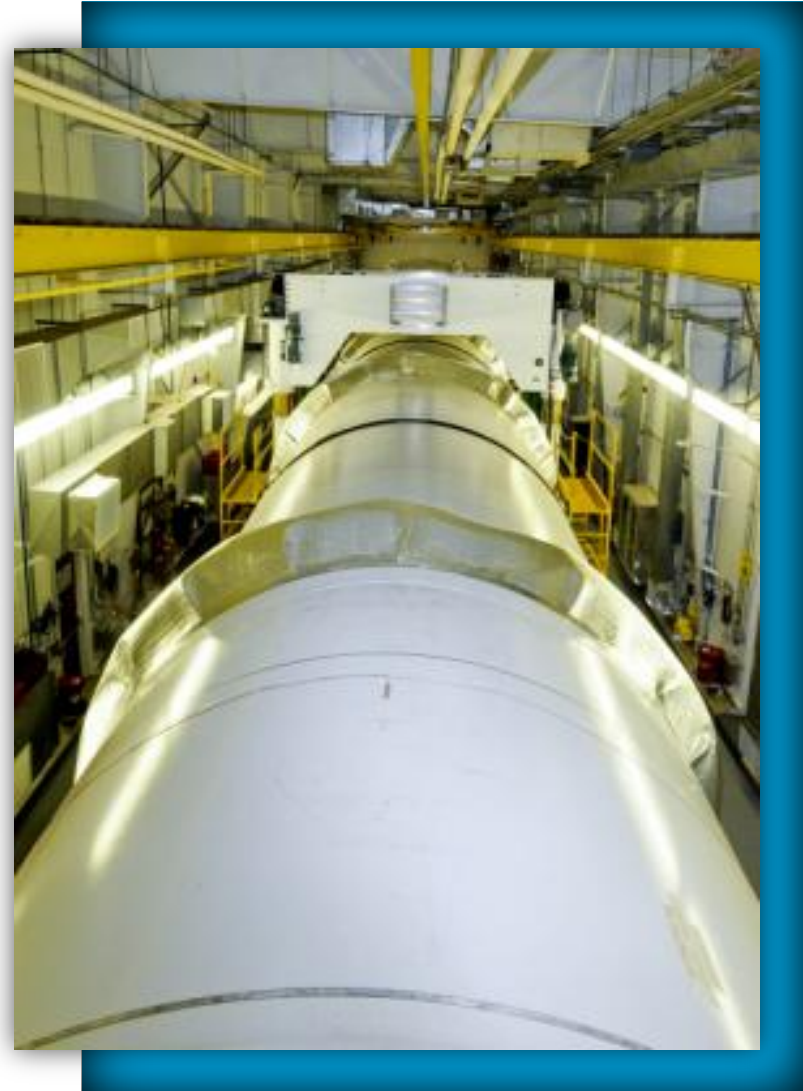
- The actual PMBT is calculated from a functional thermal model
  - This model incorporates temperature data collected from a series of thermocouples (TC) located at various positions on the motor case and inner diameter of the propellant
- Conditioning began on July 6, 2010. The PMBT was calculated to be 78 °F
- The building's temperature was gradually lowered until the inlet temperature was 35 °F. This temperature was held for three days in order to draw out the moisture and prevent freezing
  - The joint shrouds were installed during this time period

- The inlet temperature was then lowered to approximately 30 °F. Two challenges arose that impeded the conditioning from going lower
  - There was a 22 °F temperature limit on the metal hardware. Because of an inherent TC error, an additional 2 degrees was added to the restriction

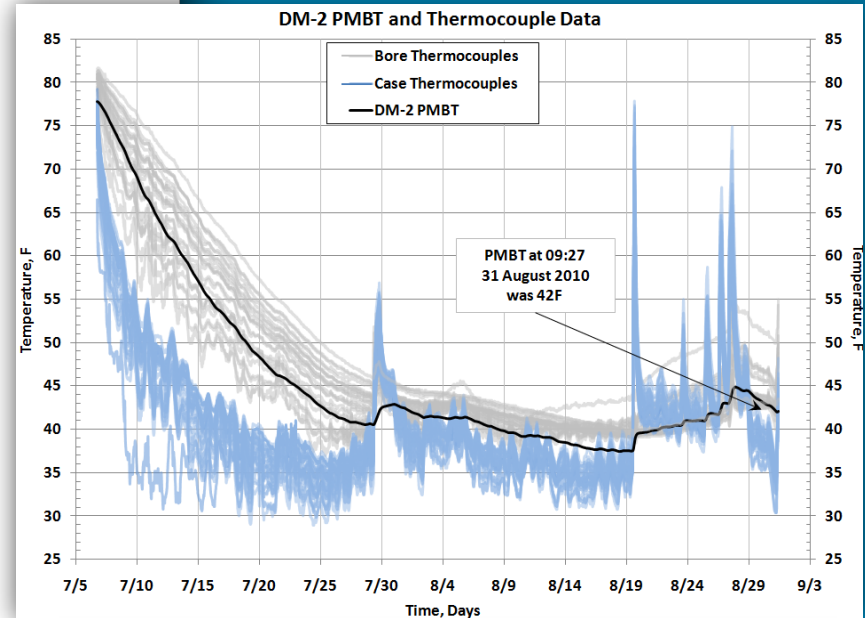
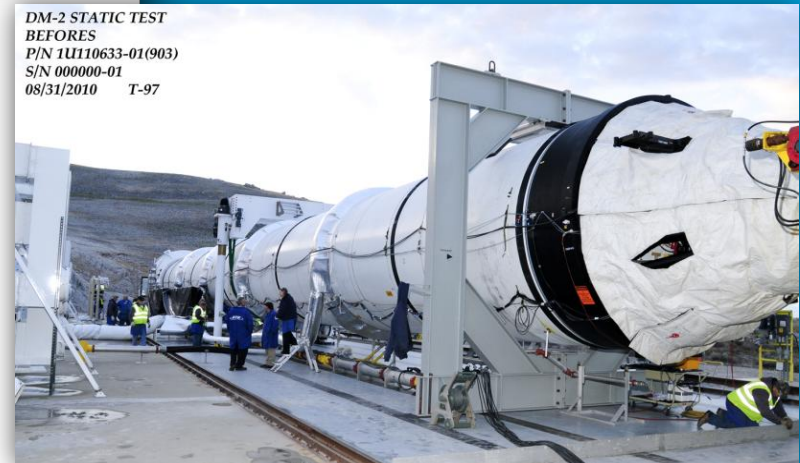
- Inlet temperatures were kept between 28 to 30 °F
- The 13 days prior to static test consisted of dry runs, hot spin tests, and radiometer and camera alignments
- Because of all the heating of the motor for these building-off activities, the last three days were dedicate to conditioning. The inlet temperature was dropped to 20 to 22 °F
- On the day of the test the building was pulled before dawn and joint shroud conditioning was activated
- The PMBT at the time of static test was calculated to be 42 °F.
- The O-rings were calculated to be 32 to 34 °F
